Inspection Report

This inspection performed in accordance with current "Standards of Practice" of the American Society of Home Inspectors.

John Doe
4769 13th St. S.W.
Canton, OH 44710

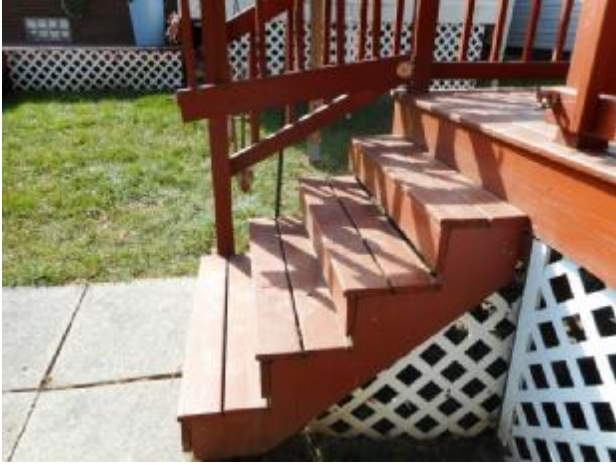
#GD1

1. **SAFETY HAZARD.** Lack of proper hand railing on the steps that lead from the deck to the back yard. Recommend a reputable contractor. (see photo 1).

Lacking proper railing

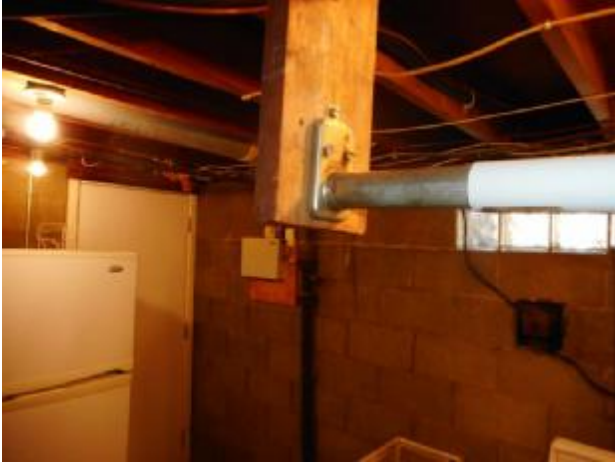
#K1

- 26
- SAFETY HAZARD.** Clothes rod is mounted too low from the ceiling in the laundry room. Recommend a reputable contractor. (see photo 1).

Low hanging mount for clothes rod

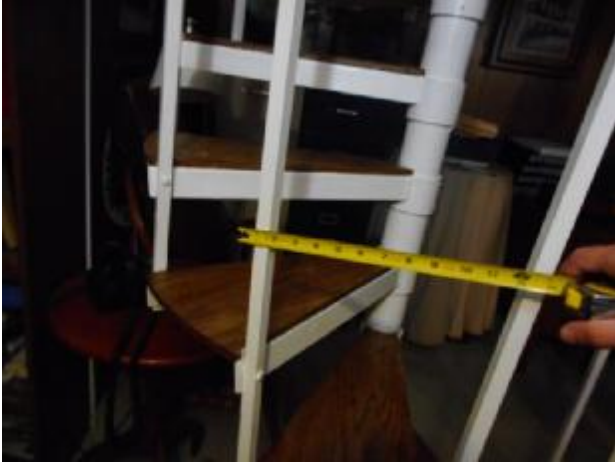
#IR1

1. SAFETY HAZARD. Balusters to the hand rail are more than 4 inches apart. Located on the spiral stair well in the living room. Recommend a reputable contractor. (see photo 01).

Gap is too large
